Equipment Development Center

# Outdoor Testing of Reflective Sign Materials

TE02L22
Technical Services, Forest Roads & Trails

By Thomas J. Nettleton Project Leader

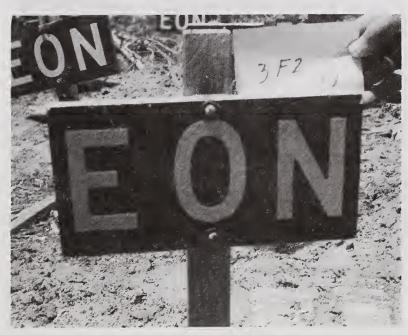
- E Excellent to good durability with no structural failures that would require maintenance (fig. 1).
- L Legible; sign message legible but maintenance would be required for esthetic purposes and to prevent deterioration (fig. 2).

Figure 1.—Test sign shows no structural failure that would require maintenance.

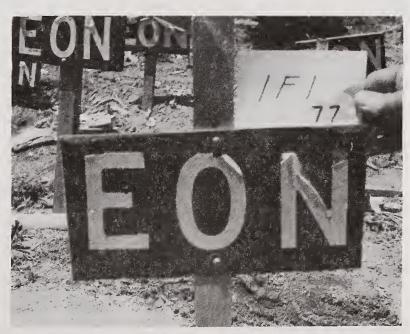
Figure 2.—Test sign message is legible but maintenance would be required for esthetic purposes and to prevent further deterioration.

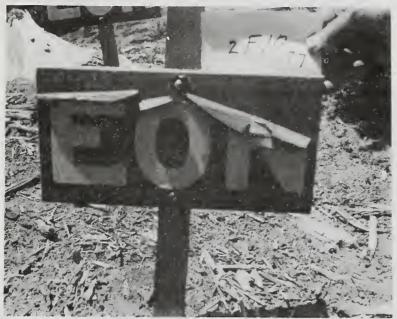
• NL — Not Legible; message unreadable, requiring immediate replacement or complete repair (fig. 3).

Figure 3.—Test sign message is becoming unreadable and sign requires immediate replacement or repair.

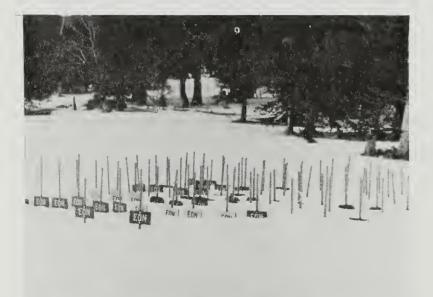
Figure 4.-3M Co. reflective signs undergoing outdoor exposure testing at Hopewell Lake, N. Mex., test site.

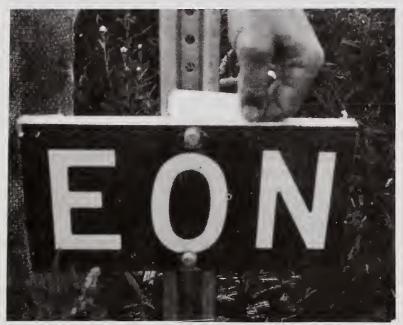
The original 50 sign combinations were evaluated in 1974, 1975, 1976, and 1977. By 1977, only six combinations had weathered well enough to meet the minimum criteria of five signs rated "E," with the sixth sign rated at least "L" (fig. 5).

Figure 5.—This sign rated excellent after 6 years of outdoor exposure.

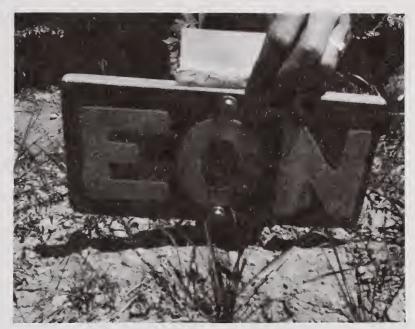
1F2 was the only successful combination that had an aluminum substrate (table 1). 2F13 was the only successful combination that had green high-intensity grade sheeting (fig. 6) (table 2). The remaining successful combinations (table 3) had brown engineering-grade sheeting, one with pressure-sensitive adhesives and one with heat-activated adhesives.

Figure 6.—This was the only successful sign combination that had green high-intensity grade sheeting.

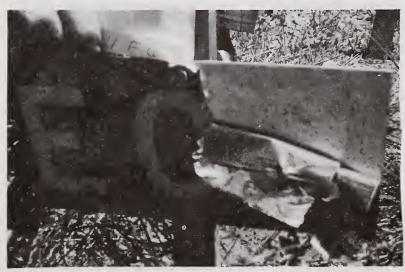
• Peeling of background sheeting was generally more severe on aluminum than on plywood (fig. 7). Severe crazing occurred on high-intensity sheeting where clear coating had been applied.

Figure 7.—Background sheeting generally peeled more severely from aluminum than plywood.

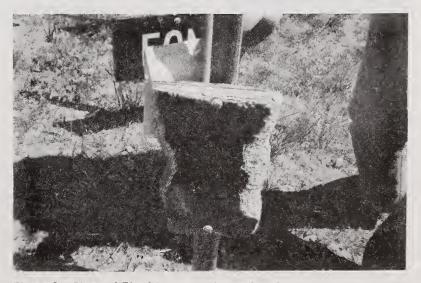
The 2C series signs had been exposed for almost 4 years when last evaluated. The 2C series tested the compatibility of Finnish plywood and 3M reflective sheeting. All 2C signs showed severe delamination and peeling of both the sheeting background and legend. Furthermore, 2C signs were severely damaged by rodents at all test sites. We suspect that additional adhesive used in 2C signs attracted these animals.

The Finnish plywood, although durable, proved to be extremely attractive to rodents at all sites, resulting in loss of the signs (fig. 8).

Figure 8.—Signs of Finnish plywood were heavily damaged by rodents.

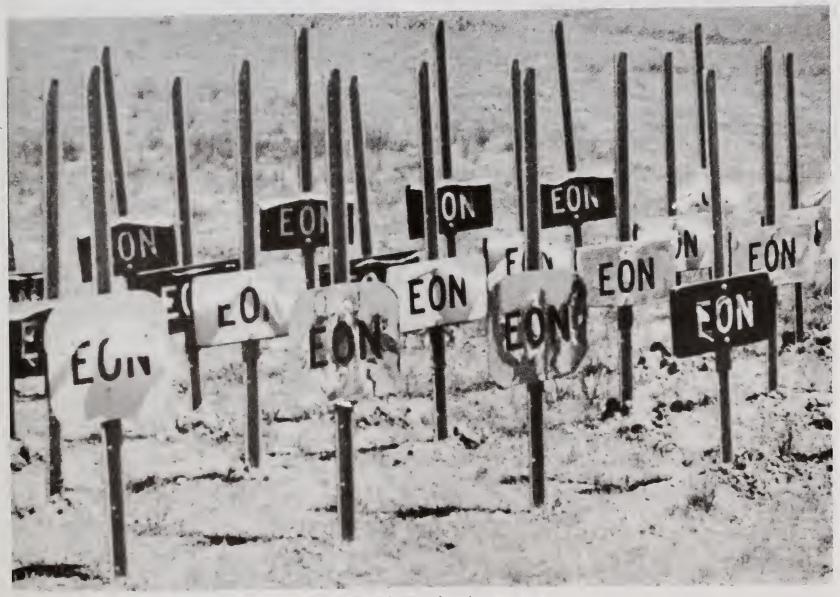
By the spring of 1978 all combinations installed at both the Mount Adams test site and the Donner Summit test site demonstrated some degree of failure (fig. 9). However, at the Hopewell Lake site, only a few of the combinations exhibited any failure. As a result, Avery removed all signs in series 1A through 5A from the test sites.

Figure.9—Early combination of Avery International materials after 2 years of outdoor exposure.

In response to these failures, the company developed new materials, modified original formulations, including adding ultraviolet ray inhibitors, and added tapes to the top edge of signs. Forty new sign combinations (series 7A-10A) were manufactured and installed in October 1978 (tables 17-20) (fig. 10). In addition, six combinations using Finnish plywood substrates

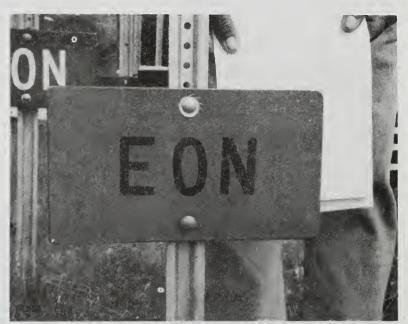
Figure 11.—Avery International sign combination installed in October 1981.

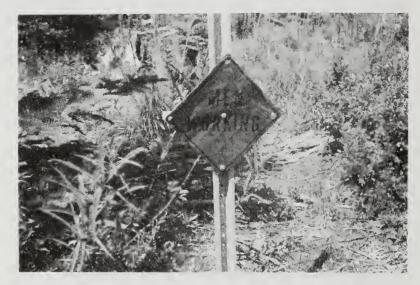
Figure 14.—Reflexite Corp.'s roll-up sign at test site.

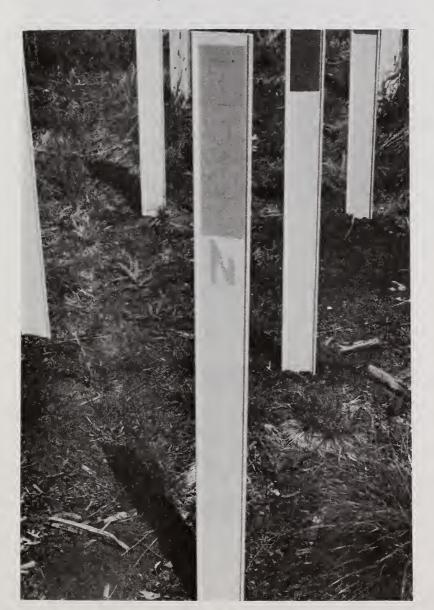
Figure 15.—Carsonite flexible delineator post with reflective sheeting installed in 1980.

Compatibility of flexible posts with reflective sheeting has not been established. Carsonite has added ultraviolet ray inhibitors, improved resin, and stabilizers to its post material. These combinations look excellent to date (1983).

Durability of reflective sheeting on the posts has not been sufficiently established at this time to recommend the use of any one specific reflective sheeting. It is recommended that 3M Co.'s Scotchcal brand transparent film #639 be used on the top edge, extending about 1 inch over the top (both sides) and at least ½ inch over reflective sheeting or top number or letter.

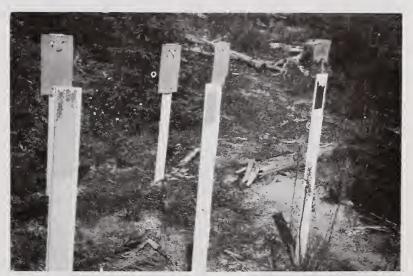
The 1976 flexible delineator posts showed a loss of resin, exposing the fiberglass fibers after 2 to 3 years of outdoor exposure. Also, the reflective sheeting was peeling and delaminating (fig. 16). The posts installed in 1979 showed slight fiber exposure, while the 1980 and 1982 series look excellent.

Figure 16.—Reflective sheeting peeling and delaminating from delineator posts after 3 years' exposure.

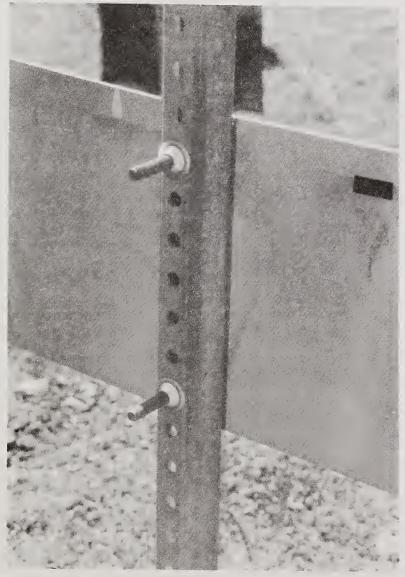
Figure 17.-Vandalgard hardware from Voi-Shan Co.

Before vandal-resistant hardware came into use at the outdoor test sites, some signs were taken from the Hopewell Lake, N. Mex., site. But since 1978, no signs have been removed by vandals. In the outdoor tests, the vandal-resistant hardware has proven to be durable and easy to use. It should be recommended for use with all Forest Service signs.

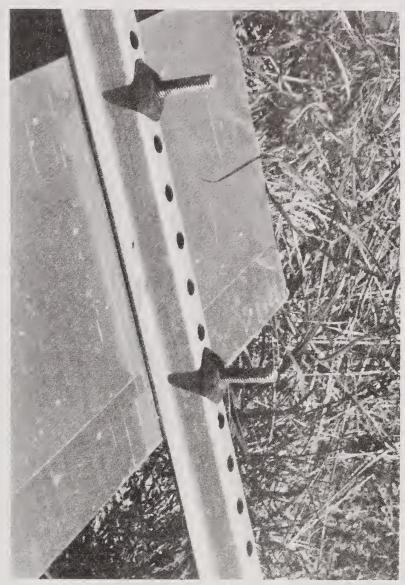
Figure 18.—Vandal-resistant hardware from Tufnut Works,
